SUBARU

SERVICE BULLETIN

APPLICABILITY: 2002MY Impreza WRX
SUBJECT: Fuel Smell in Cold Weather

NUMBER: 09-36-03
DATE: 04/01/03

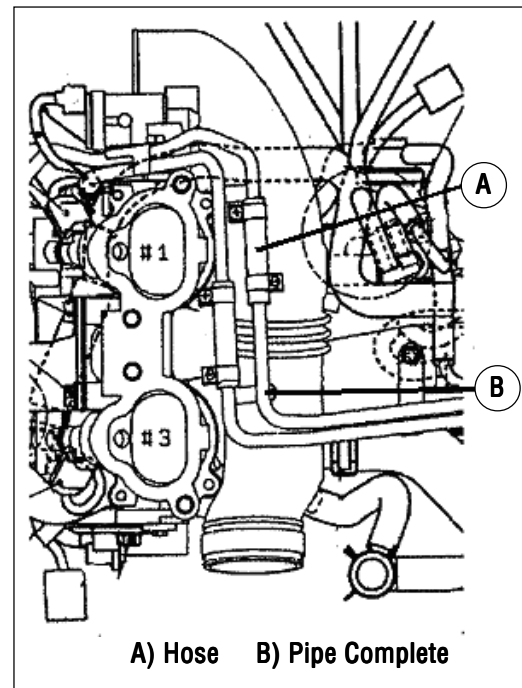
Some 2002 model Impreza WRX (2.0L Turbo) may experience a fuel smell in cold weather (temperature < 14°F) from the rubber hose connector, located under the intake manifold, between two direct fuel-feed metal lines to the injectors.

The changing of the pipe and hose size was adopted, starting with engine number 673467 to better align the two fuel lines. This was accomplished by shortening the fuel pipe and lengthening the hose both by 30mm. To complete this service procedure, you must replace the fuel pipe assembly and hose as a set.

Replace the pipe and hose as a set.

PART NUMBER	DESCRIPTION
17544AA134	Pipe complete (30mm shorter than Old one)
807707140	Hose (30mm longer than Old one)
