SUBARU

SERVICE BULLETIN

APPLICABILITY: 1998~current MY Forester
 2000~current MY Legacy/Outback Wagon
 2002~current MY Impreza Wagon
SUBJECT: Rear Gate Stay Diagnosis

NUMBER: 12-85-05R
DATE: 02/25/05

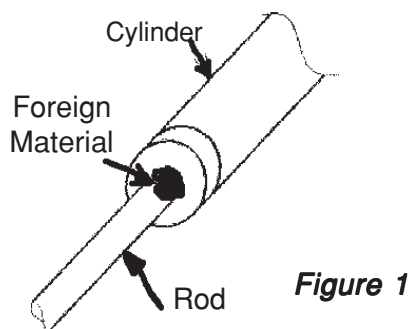
Figure 1

Check the lower end of the rear gate stay for foreign material. If foreign material (as an example, sand particle) gets lodged at the end of the cylinder it will cause the gas within the cylinder to leak (see Figure1). If foreign material is found lodged at the end of the cylinder, the cylinder should be replaced.

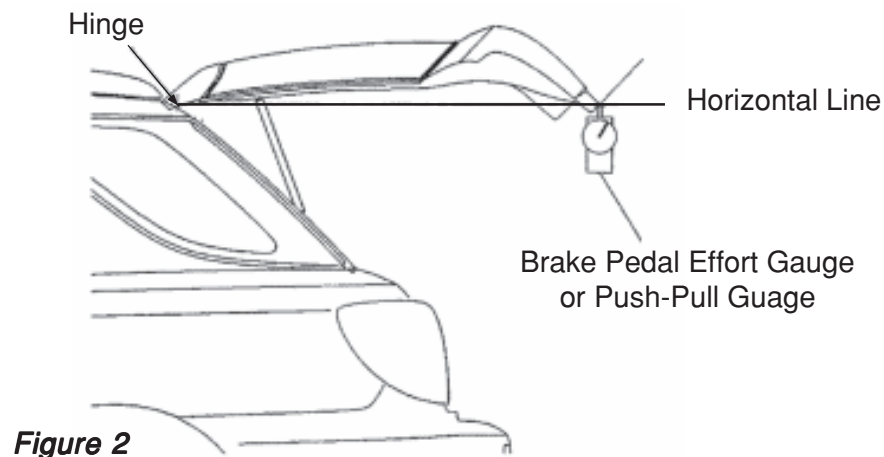
Disconnect one stay (refer to the applicable service manual) at a time. Be sure to zero the needle or gauge on your measuring device before proceeding with any testing. Using the brake pedal effort gauge, measure the load by placing the gauge at the lower edge of the rear gate (see Figure 2). Push up on the rear gate using the gauge and stop when the gate edge is parallel (horizontal) with the rear gate hinge. Record your measurement (see figure 2). Compare your measurements with the ones on the following chart to determine if replacement is necessary. If the measurement is within specification, reinstall the removed stay and remove the opposite one.

Repeat the measuring procedure. If both stays are within specification no replacement is necessary.
