SUBARU

SERVICE BULLETIN

NUMBER: 12-79-03

SUBJECT: Front Door Panel Weather Strip

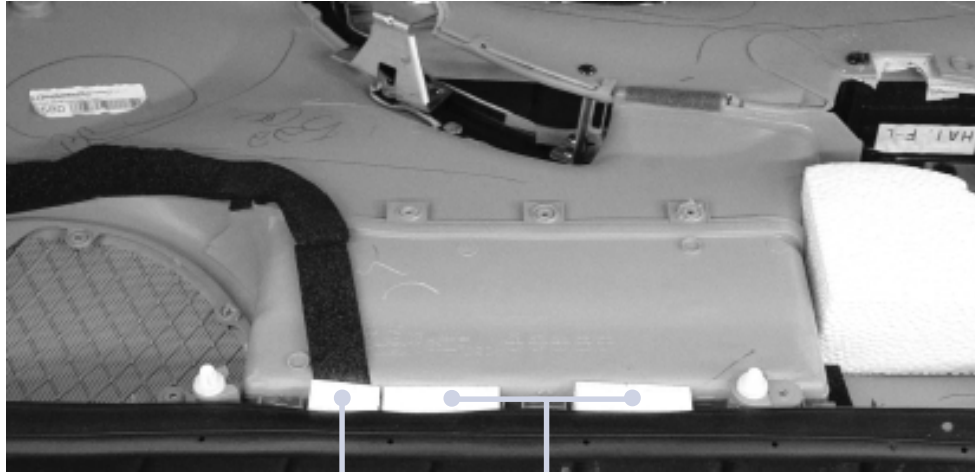
In the event you encounter a customer complaint that the lower front door weather strip is detached or hanging loose, the following repair method should be used in lieu of replacing the entire weather strip or door trim panel assembly. For weather strips which are loose only, replacement is not an option under warranty.

- 3) Insert the three holders into the space between the weather strip and the bottom of the door pocket protrusion, ensuring that the holder is wedged flush with the weather strip (see picture below).

**Holder W/S A
94285AE021**

**Holder W/S B
94285AE031**
