1. Door Glass

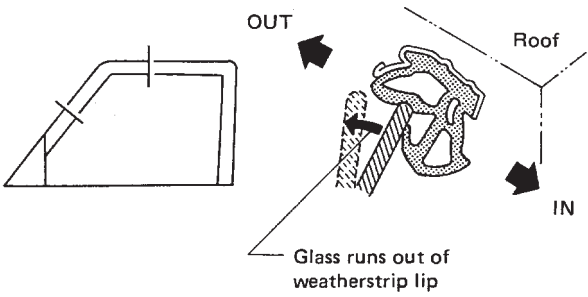
Condition	Apparent cause/Correction
<p>Glass in fully closed position</p>	<p>1) Glass runs out of weatherstrip lip when considerable hand pressure is applied to it from inside.</p>

<p style="text-align: right;">G5M0502</p> <p>(This condition may cause wind/booming noise during high-speed operation.)</p>	<ul style="list-style-type: none"> ● Insufficient upward travel of glass Increase upward travel of glass.
	<p>2) Clearance exists between glass and weatherstrip when light hand pressure is applied to it at center and rear pillar locations.</p>

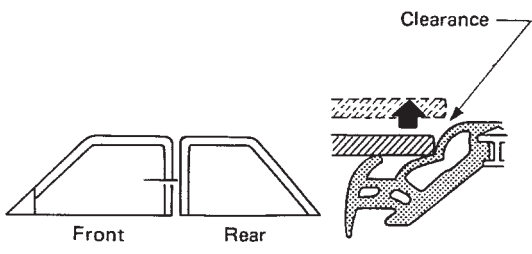
<p style="text-align: right;">G5M0503</p> <p>(This condition may cause wind noise and/or water leakage.)</p>	<ul style="list-style-type: none"> ● Insufficient glass-to-door weatherstrip contact Check stabilizer and glass for proper contact. Increase contact using upper sash adjustment bolt. ● Improper adjustment of striker in in-out direction Close door and check for alignment of striker with vehicle body.

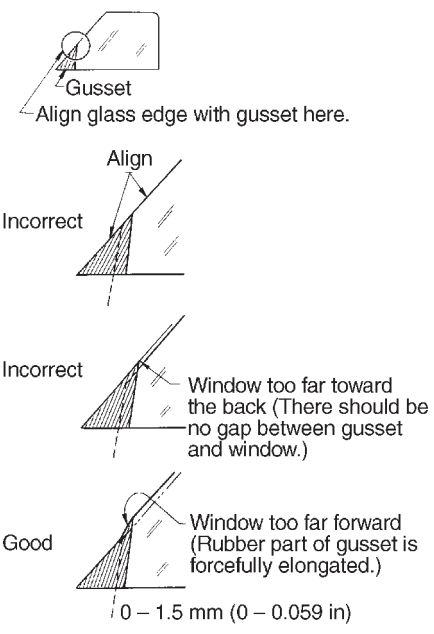
<p>3) Adjust door glass so that it is aligned with door rearview mirror gusset.</p>

<p style="text-align: right;">H5M0672A</p>	<ul style="list-style-type: none"> ● Window is not properly adjusted in up-down/fore-aft direction. Adjust window. If necessary, move B channel regulator to eliminate window tilt. ● Gusset is not properly adjusted in fore-aft direction. Adjust gusset after loosening all bolts and nuts which tighten it.

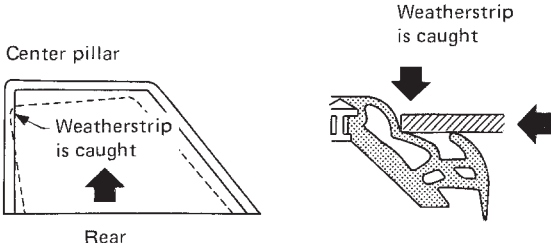
Condition	Apparent cause/Correction
<p>Raise or lower window glass</p>	<p>1) Center pillar weatherstrip is caught by rear window glass when glass is raised.</p>

<p style="text-align: right;">G5M0508</p>	<ul style="list-style-type: none"> ● Improper fore-aft or in-out alignment of window glass Lower B channel regulator to tilt window glass back.
	<p>2) Window glass tilts forward by more than 2 mm (0.08 in).</p>

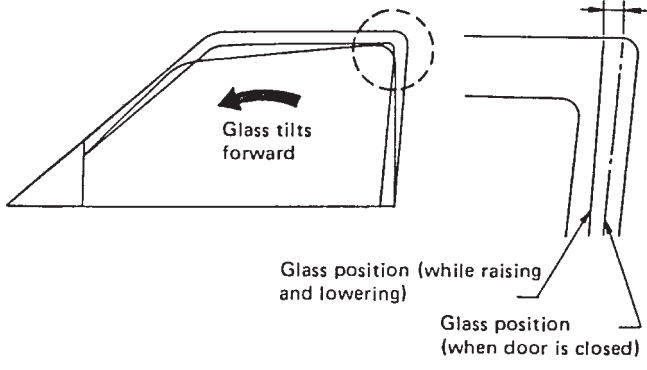
<p style="text-align: right;">G5M0509</p> <p>Excessive forward tilt of glass is due to excessive glass contact which causes reaction of center pillar weatherstrip. Glass can be tilted forward due to increase in reaction of shoulder weatherstrip or free play between sash and roller. Taking these symptoms into account, glass should be aligned.</p>	<ul style="list-style-type: none"> ● Excessive glass contact pressure or improper in-out alignment <ol style="list-style-type: none"> 1) Lower B channel regulator to tilt window glass rearward. 2) Reduce contact pressure using upper sash adjustment bolt.
