1. Door Glass

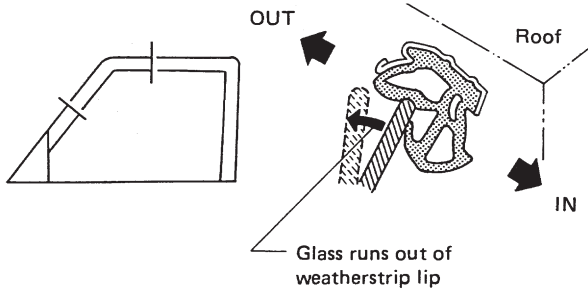
Condition	Apparent cause/Correction
<p>Glass in fully closed position</p>	<p>1) Glass runs out of weatherstrip lip when considerable hand pressure is applied to it from inside.</p>

<p style="text-align: right;">G5M0502</p> <p>(This condition may cause wind/booming noise during high-speed operation.)</p>	<ul style="list-style-type: none"> ● Insufficient upward travel of glass Increase upward travel of glass.
	<p>2) Clearance exists between glass and weatherstrip when light hand pressure is applied to it at center and rear pillar locations.</p>

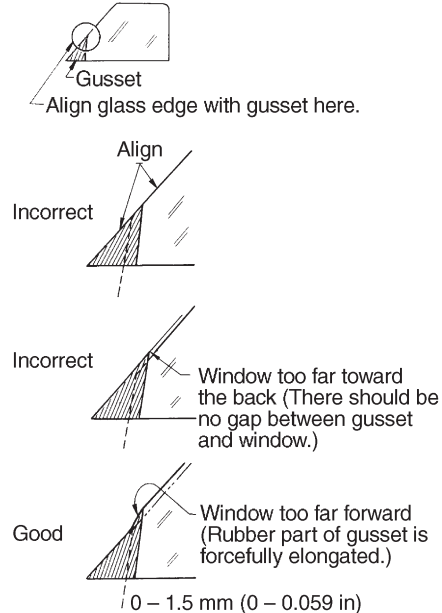
<p>3) Adjust door glass so that it is aligned with door rearview mirror gusset.</p>

<p style="text-align: right;">H5M0672A</p>	<ul style="list-style-type: none"> ● Window is not properly adjusted in up-down/fore-aft direction. Adjust window. If necessary, move "B" channel for regulator to eliminate window "tilt". ● Gusset is not properly adjusted in fore-aft direction. Adjust gusset after loosening all bolts and nuts with tightening it.

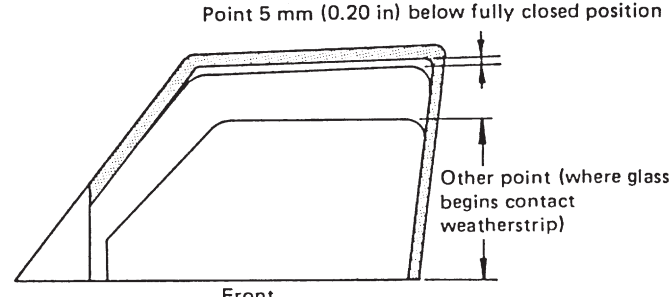
<p>Raise or lower window glass</p>	<p>1) Considerable effort or time is required to operate regulator. Standard operating effort:</p> <ul style="list-style-type: none"> Entire up-down travel except for point 5 mm (0.20 in) below fully closed position: 29.4 N (3.0 kg, 6.6 lb) Point 5 mm (0.20 in) below fully closed position: 45.0 N (4.5 kg, 10.12 lb)

<p style="text-align: right;">G5M0507</p>	<ul style="list-style-type: none"> Sliding resistance increased due to high stabilizer-to-glass contact pressure Reduce contact by mounting inner stabilizer to inside of the car. High glass-to-windshield contact pressure Reduce contact using upper sash adjustment bolt. Unequal contact adjustment stroke between front and rear sashes Set to equal stroke. Tilt of rear sash adjustment bolt mounting bracket Correct tilt of bracket so it is parallel to inner panel.

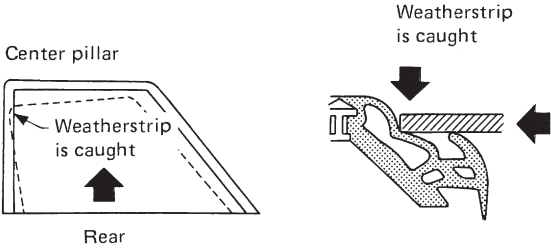
Condition	Apparent cause/Correction
<p>Raise or lower window glass</p>	<p>2) Center pillar weatherstrip is caught by rear window glass when glass is raised.</p>

<p style="text-align: right;">G5M0508</p>	<ul style="list-style-type: none"> Improper fore-aft or in-out alignment of window glass Lower regulator "B" channel to tilt window glass back.
	<p>3) Glass tilts forward by more than 2 mm (0.08 in).</p>
