1. Door Glass

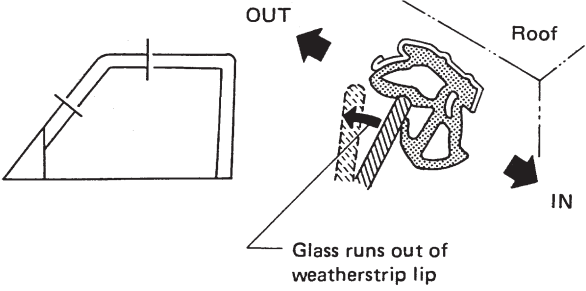
Condition	Apparent cause/Correction
<p>Glass in fully closed position</p>	<p>1) Glass runs out of weatherstrip lip when considerable hand pressure is applied to it from inside.</p>

<p style="text-align: right;">G5M0502</p> <p>(This condition may cause wind/booming noise during high-speed operation.)</p>	<ul style="list-style-type: none"> <li>● Insufficient upward travel of glass Increase upward travel of glass.</li> </ul>
	<p>2) Clearance exists between glass and weatherstrip when light hand pressure is applied to it at center and rear pillar locations.</p>

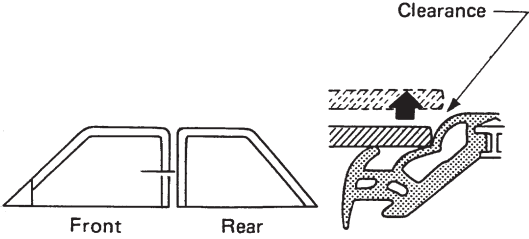
<p style="text-align: right;">G5M0503</p> <p>(This condition may cause wind noise and/or water leakage.)</p>	<ul style="list-style-type: none"> <li>● Insufficient glass-to-door weatherstrip contact Check stabilizer and glass for proper contact. Increase contact using upper sash adjustment bolt.</li> <li>● Improper adjustment of striker in in-out direction Close door and check for alignment of striker with vehicle body.</li> </ul>

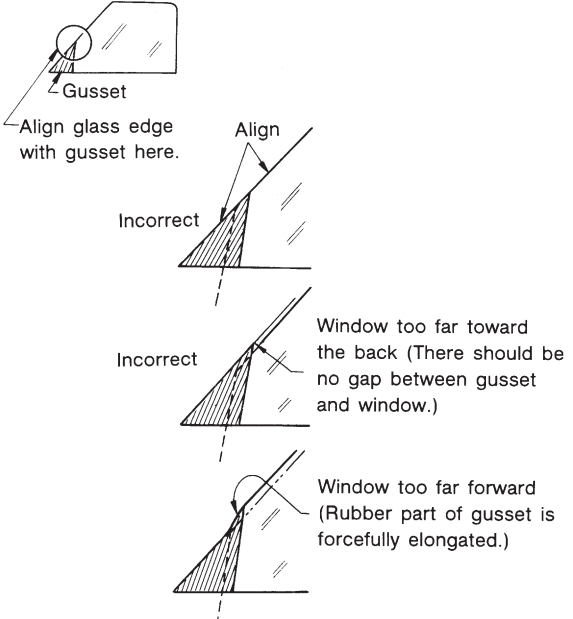
<p>3) Adjust door glass so that it is aligned with door rearview mirror gusset.</p>

<p style="text-align: right;">G5M0504</p>	<ul style="list-style-type: none"> <li>● Window is not properly adjusted in up-down/fore-aft direction. Adjust window. If necessary, move B channel regulator to eliminate window tilt.</li> <li>● Gusset is not properly adjusted in fore-aft direction. Adjust gusset after loosing all bolts and nuts with tightening it.</li> </ul>

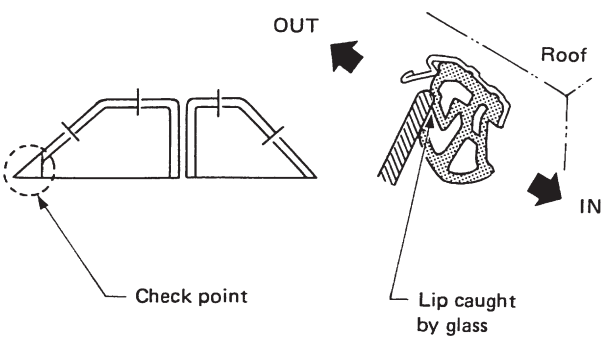
Condition	Apparent cause/Correction
<p>Door in fully closed/open position</p>	<p>1) Glass rides over weatherstrip lip when door is closed.</p>

<p style="text-align: right;">G5M0505</p> <p>(This condition increases wind/booming noise, leakage and/or effort required to close door.)</p>	<ul style="list-style-type: none"> <li>● Improper up-down and in-out glass alignments Adjust glass for up-down and in-out alignments (incl. rear sash, upper stopper adjustment, etc.). If necessary, correct glass tilt by moving B channel regulator.</li> </ul>
	<p>2) Edge of glass contacts retainer when door is fully closed.</p>

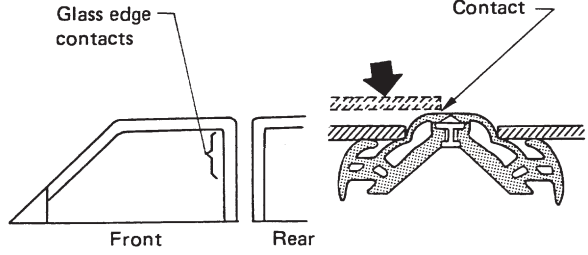
<p style="text-align: right;">G5M0506</p>	<ul style="list-style-type: none"> <li>● Improper glass-to-center pillar weatherstrip or excessive glass contact to weatherstrip</li> <li>● Excessive adjusting in contact to weatherstrip Causes rear edge of glass to tilt inboard closer to center pillar. Adjust rear sash adjustment bolt to reduce glass contact to weatherstrip.</li> </ul>

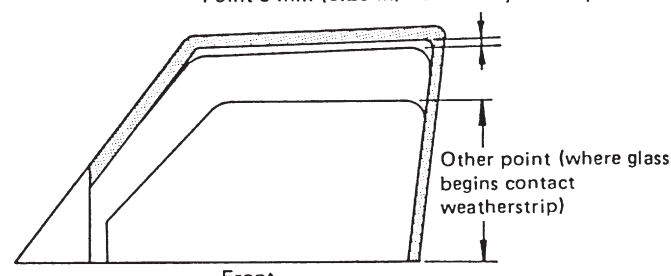
<p>Raise or lower window glass</p>	<p>1) Considerable effort or time is required to operate regulator. Standard operating effort:</p> <ul style="list-style-type: none"> <li>● Entire up-down travel except for point 5 mm (0.20 in) below fully closed position: 29.4 N (3.0 kg, 6.6 lb)</li> <li>● Point 5 mm (0.20 in) below fully closed position: 44.1 N (4.5 kg, 9.9 lb)</li> </ul> <p style="text-align: center;">Point 5 mm (0.20 in) below fully closed position</p>

<p style="text-align: right;">G5M0507</p>	<ul style="list-style-type: none"> <li>● Sliding resistance increased due to high stabilizer-to-glass contact pressure. Reduce contact by mounting inner stabilizer to inside of the vehicle.</li> <li>● High glass-to-windshield contact pressure Reduce contact using upper sash adjustment bolt.</li> <li>● Unequal contact adjustment stroke between front and rear sashes Set to equal stroke.</li> <li>● Tilt of rear sash adjustment bolt mounting bracket Correct tilt of bracket so it is parallel to inner panel.</li> </ul>
