SERVICE BULLETIN

APPLICABILITY: All Models
SUBJECT: Cylinder Head Gasket (residual carbon deposits and rubber coating removal)

NUMBER: 02-100-06R
DATE: 10/31/06

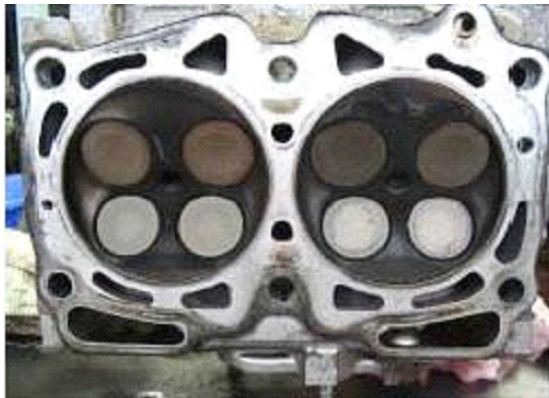
Removed Cylinder Head

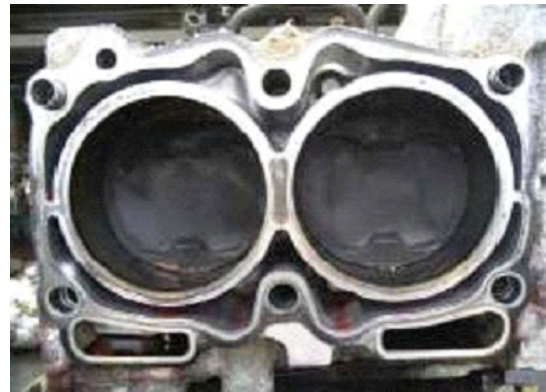
Cylinder Block after Head Removal

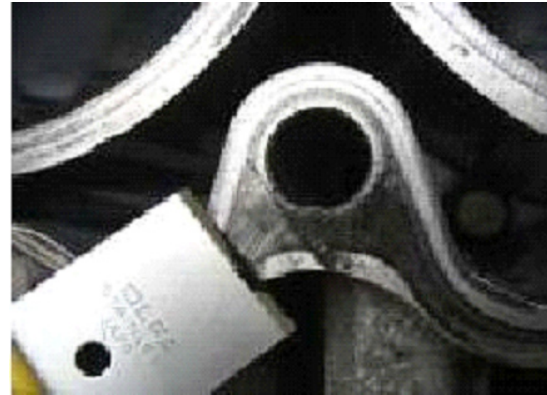
Rubber coating being removed

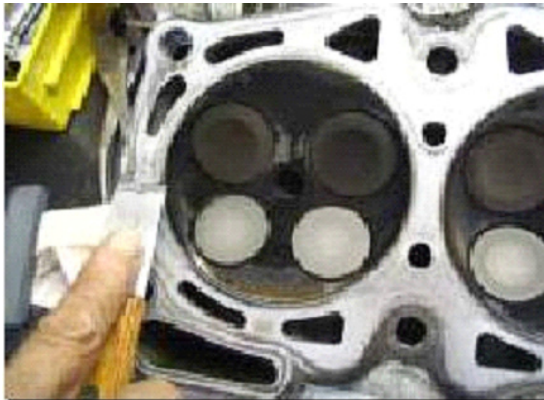
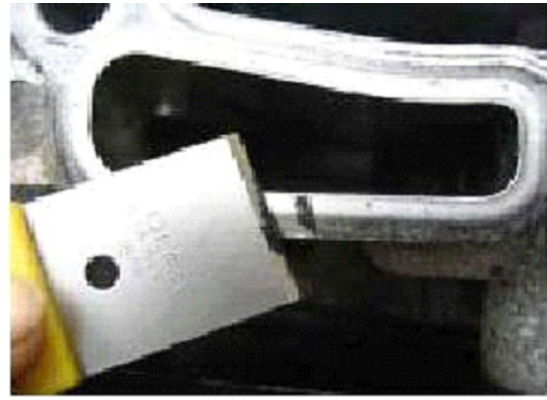
Rubber coating being removed

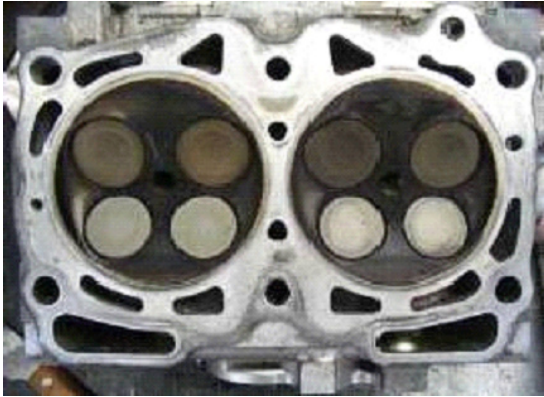
Finished cleaning (head)

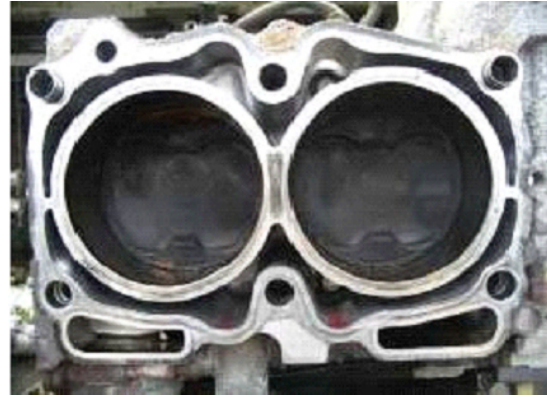
Finished cleaning (block)

NOTE: After removing carbon deposit and rubber coating, clean the surfaces using a rag and cleaning solvent.

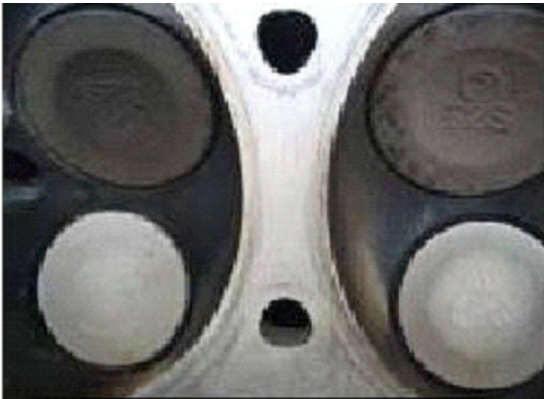
After cleaning bore sealing portion (head)

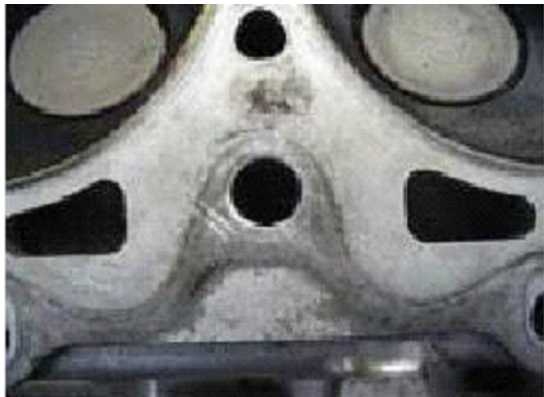
After cleaning coolant sealing portion (head)

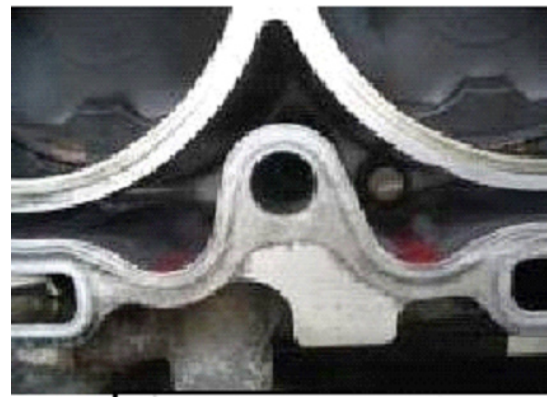
After cleaning coolant sealing portion (block)

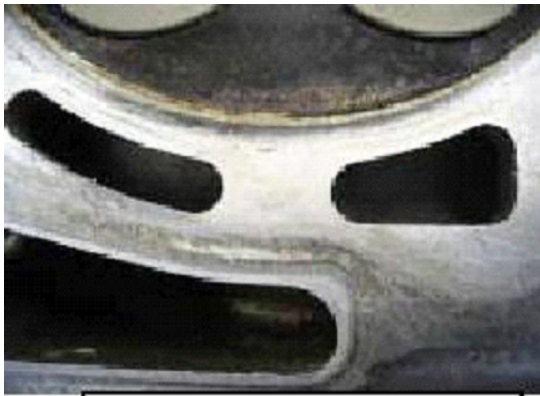
After cleaning oil sealing portion (head)

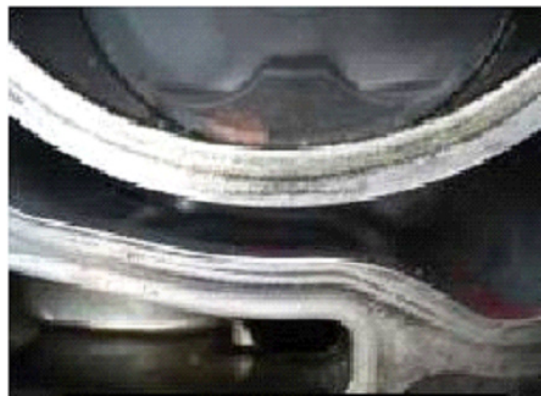
After cleaning oil sealing portion (block)
