19. Rear Turn Signal Light Bulb

S914421

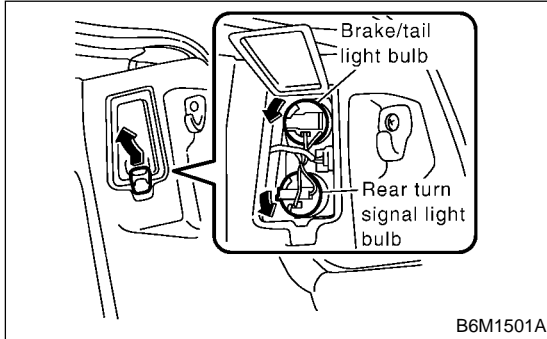
1. SEDAN S914421A1801

- 1) Open trunk lid and remove cover.

- 2) Turn the socket and remove the bulb.

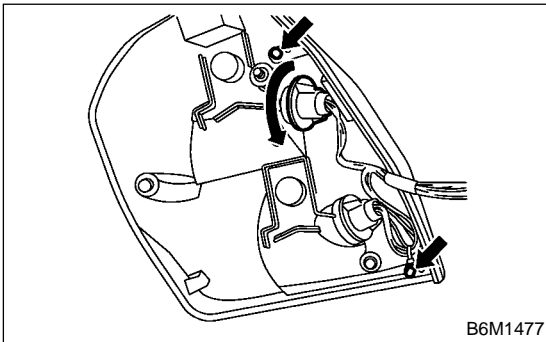
2. WAGON S914421A1802

- 1) Remove rear combination light assembly. <Ref. to LI-33 WAGON, REMOVAL, Rear Combination Light Assembly.>
- 2) Remove the light cover mounting screws then detach the cover.
- 3) Turn the socket and remove the bulb.
