**SERVICE BULLETIN**

**APPLICABILITY:** 2000MY~2004MY Legacy Vehicles  
**SUBJECT:** Sunshade for Rear Sunroof on  
 Dual Sunroof Models

**NUMBER:** 12-80-03  
**DATE:** 05/19/03

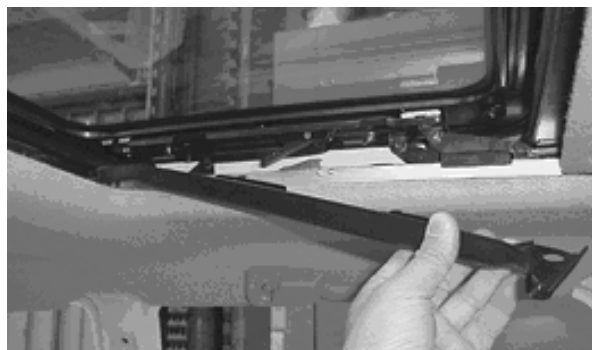
**FIGURE A**

- 1) Pull the rear sunshade open and detach the plastic clips that hold up the track covers (fig. A).

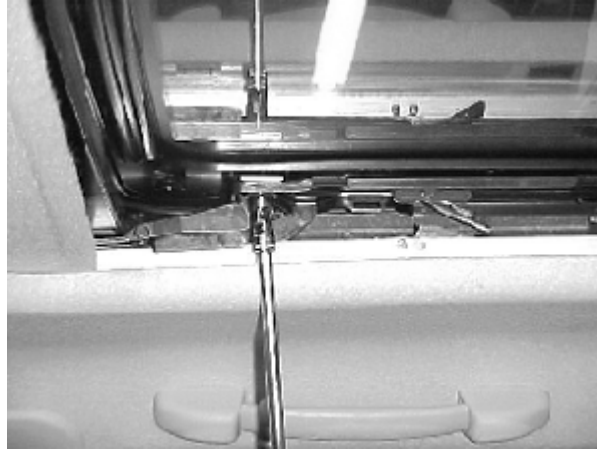
***FIGURE B***

- 2) Remove the lid installation nuts (two on each side, fig. B) and then remove the shim and glass lid.

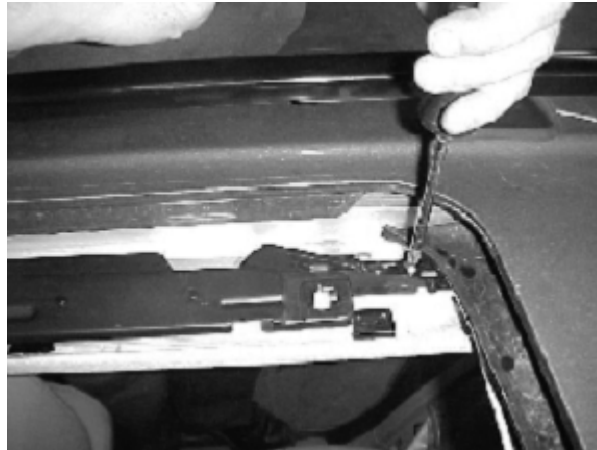
***FIGURE C***

- 3) Place protective tape around the sunroof opening to protect the paint from damage.
- 4) Remove the screw (fig. C) and the clip (fig. D) to free the arm.

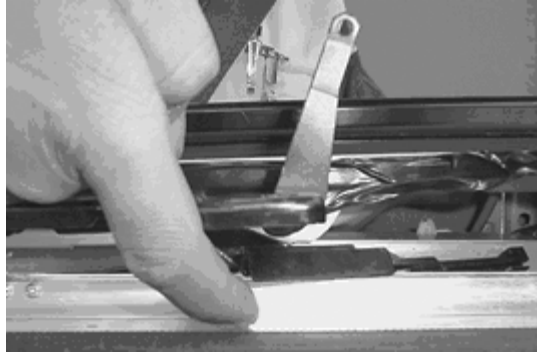
**FIGURE E**

- 5) Remove the drain plate and guide (the guide is easily removed by pushing the part outward (fig. E)).

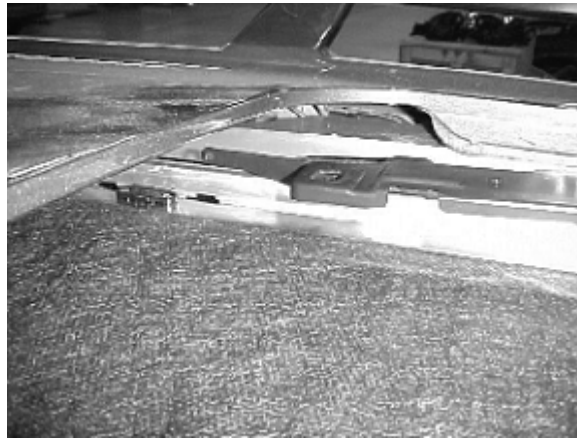
**FIGURE F**

- 6) Angle the arm parallel to the ground using a piece of tape (fig. F and fig. G).  
If the arm is not parallel it will interfere with other components when the sunroof is opened.

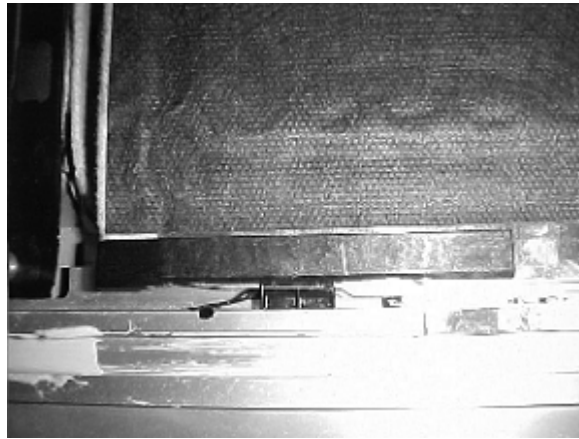
**FIGURE H**

- 7) Pull the sunshade closed, then operate the sunroof to the full open position ensuring the sunshade stays closed.
- 8) Remove the plastic sheet springs (four on each side) from the sunshade frame by prying them with a small screwdriver (fig. H).
