Rear Side Marker Light Bulb

LIGHTING SYSTEM

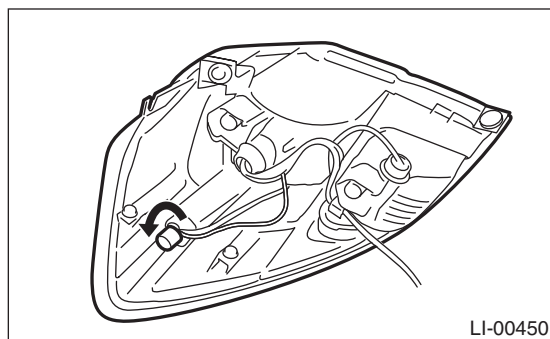
2) Turn the socket and remove the bulb.
