5. Pipe Assembly (Power Steering System)

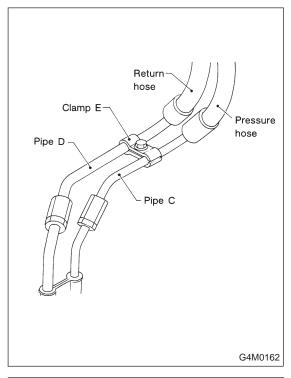
4) Remove clamp E from pipes C and D.

- 5) Disconnect pipe C from pipe (on the gearbox side). **CAUTION:**
- When disconnecting pipe C, use two wrenches to prevent deformities.
- Be careful to keep pipe connections free from foreign matter.

6) Remove bolt A.

Disconnect pipe C from oil pump. Disconnect pipe D from oil tank.

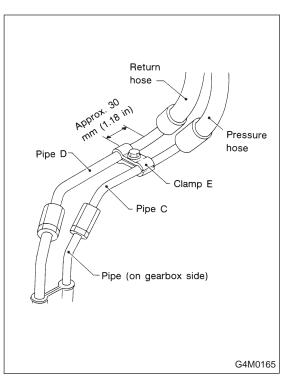
- 3) Temporarily connect pipes C and D to pipes (on the gearbox side).
- 4) Temporarily install clamp E on pipes C and D.

CAUTION:

Ensure that the "8" letter side of clamp E is on the pipe C side.

5) Tighten joint nut.

6) Tighten clamp E firmly.

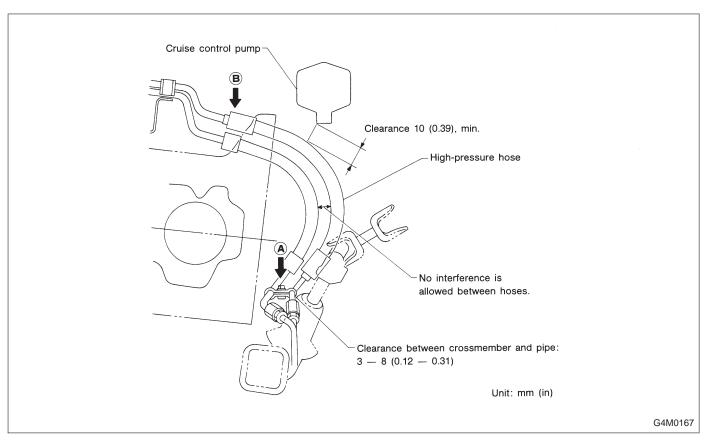
11) Finally check clearance between pipes and/or hoses, as shown above.

If clearance between cruise control pump and power steering hose is less than 10 mm (0.39 in), proceed as follows:
