# 1. Power Steering

## 1. STEERING CONDITION

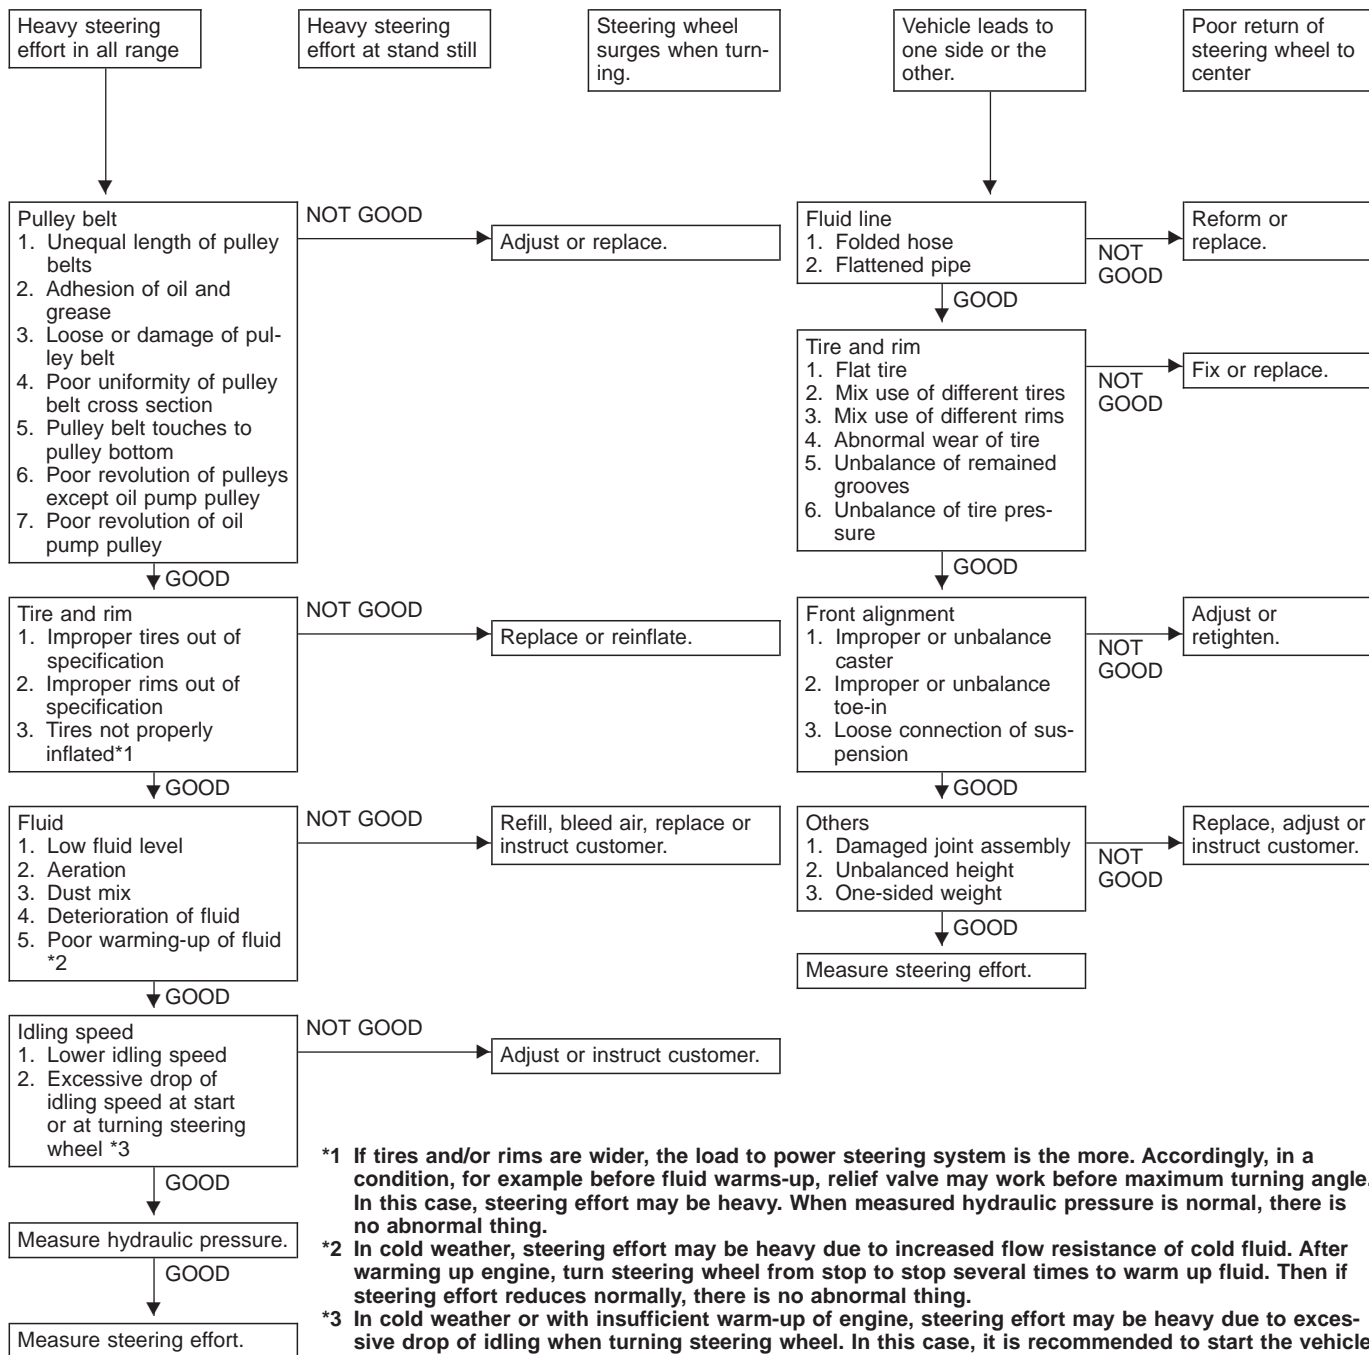
\*1 If tires and/or rims are wider, the load to power steering system is the more. Accordingly, in a condition, for example before fluid warms-up, relief valve may work before maximum turning angle. In this case, steering effort may be heavy. When measured hydraulic pressure is normal, there is no abnormal thing.

\*2 In cold weather, steering effort may be heavy due to increased flow resistance of cold fluid. After warming up engine, turn steering wheel from stop to stop several times to warm up fluid. Then if steering effort reduces normally, there is no abnormal thing.

\*3 In cold weather or with insufficient warm-up of engine, steering effort may be heavy due to excessive drop of idling when turning steering wheel. In this case, it is recommended to start the vehicle with increasing engine speed than usual. Then if steering effort reduces normally, there is no abnormal thing.

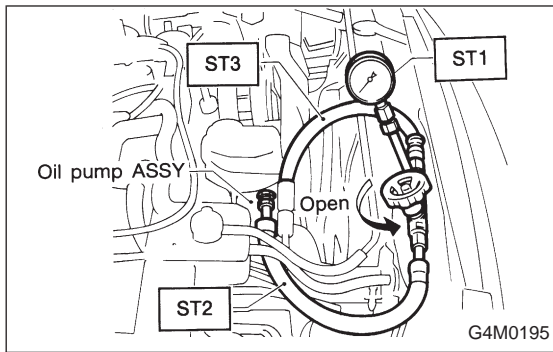
1) Using STs, measure regulator pressure.

**Regulator pressure:**

**981 kPa (10 kg/cm<sup>2</sup>, 142 psi) or less**

ST1	925711000	PRESSURE GAUGE
ST2	926220000	ADAPTER B
ST3	926210000	ADAPTER A

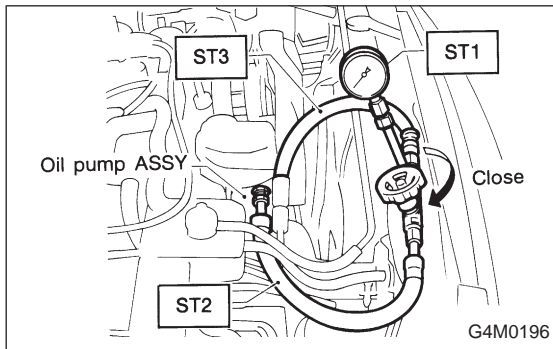
2) Using STs, measure relief pressure.

**Relief pressure:**

**7,159 — 7,748 kPa**

**(73 — 79 kg/cm<sup>2</sup>, 1,038 — 1,123 psi)**

ST1	925711000	PRESSURE GAUGE
ST2	926220000	ADAPTER B
ST3	926210000	ADAPTER A

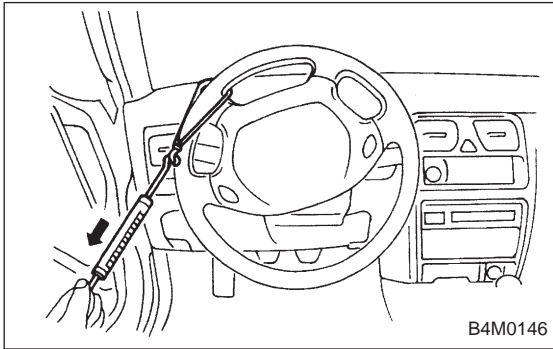
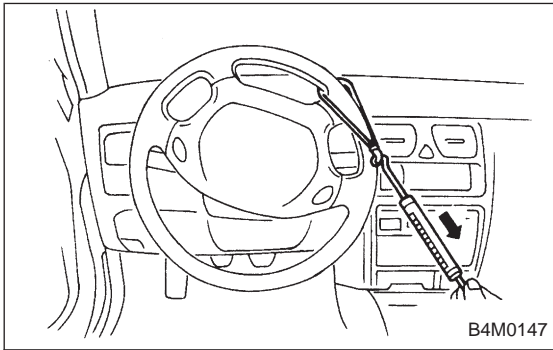
● Measurement of steering effort is as shown in the figures.

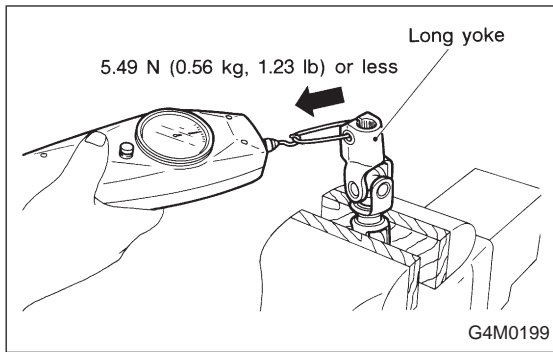
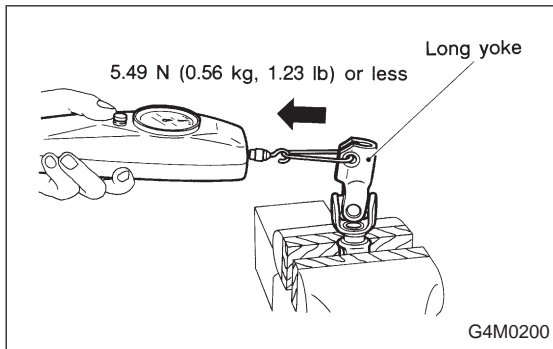
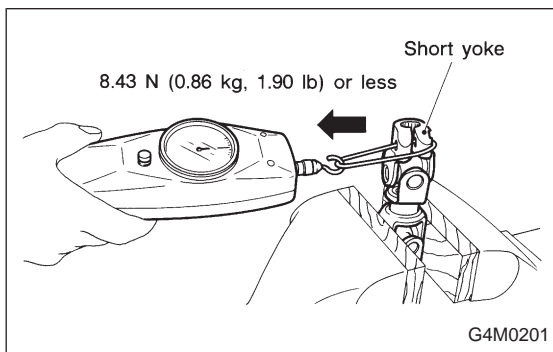
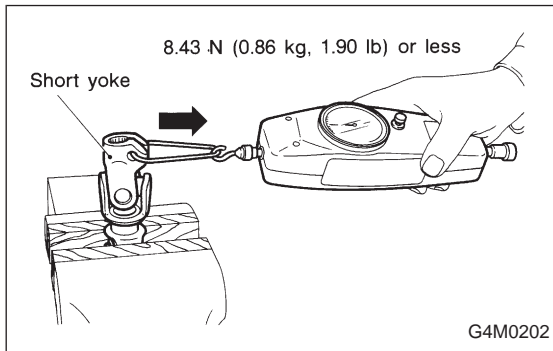
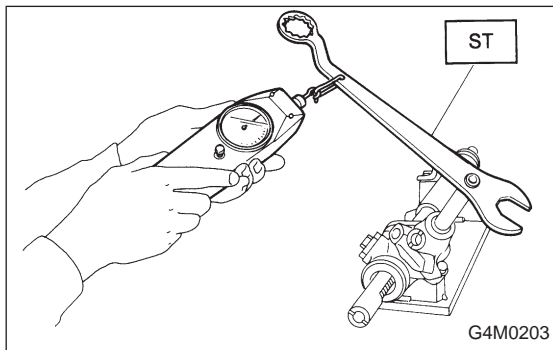
- Measurement of folding torque of universal joint is as shown in the figures.

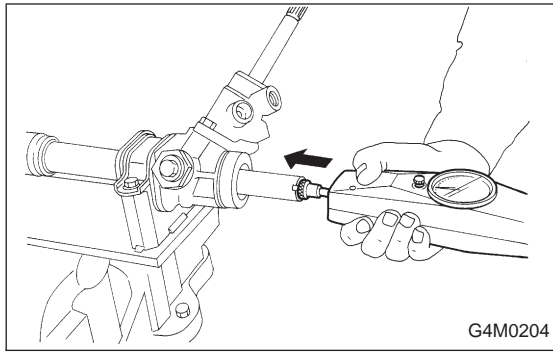
G4M0204

NOTE:  
Using ST, measure resistances of gearbox.

ST 926230000 SPANNER

**Rotating resistance:**

***Straight-ahead position within 30 mm (1.18 in) from rack center***

***Less than 11.18 N (1.14 kg, 2.51 lb)***

***Maximum allowable torque***

***15.7 N (1.6 kg, 3.5 lb)***

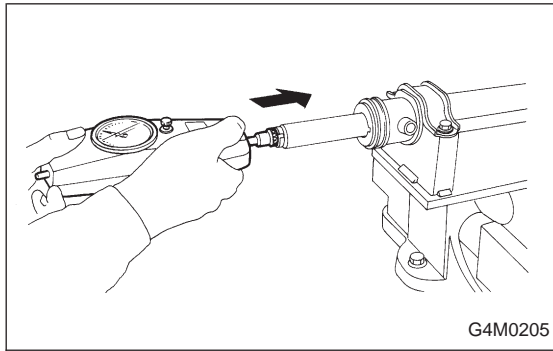
G4M0205

**Sliding resistance:**  
**Right-turn steering**  
**304 N (31 kg, 68 lb) or less**  
**Left-turn steering**  
**304 N (31 kg, 68 lb) or less**

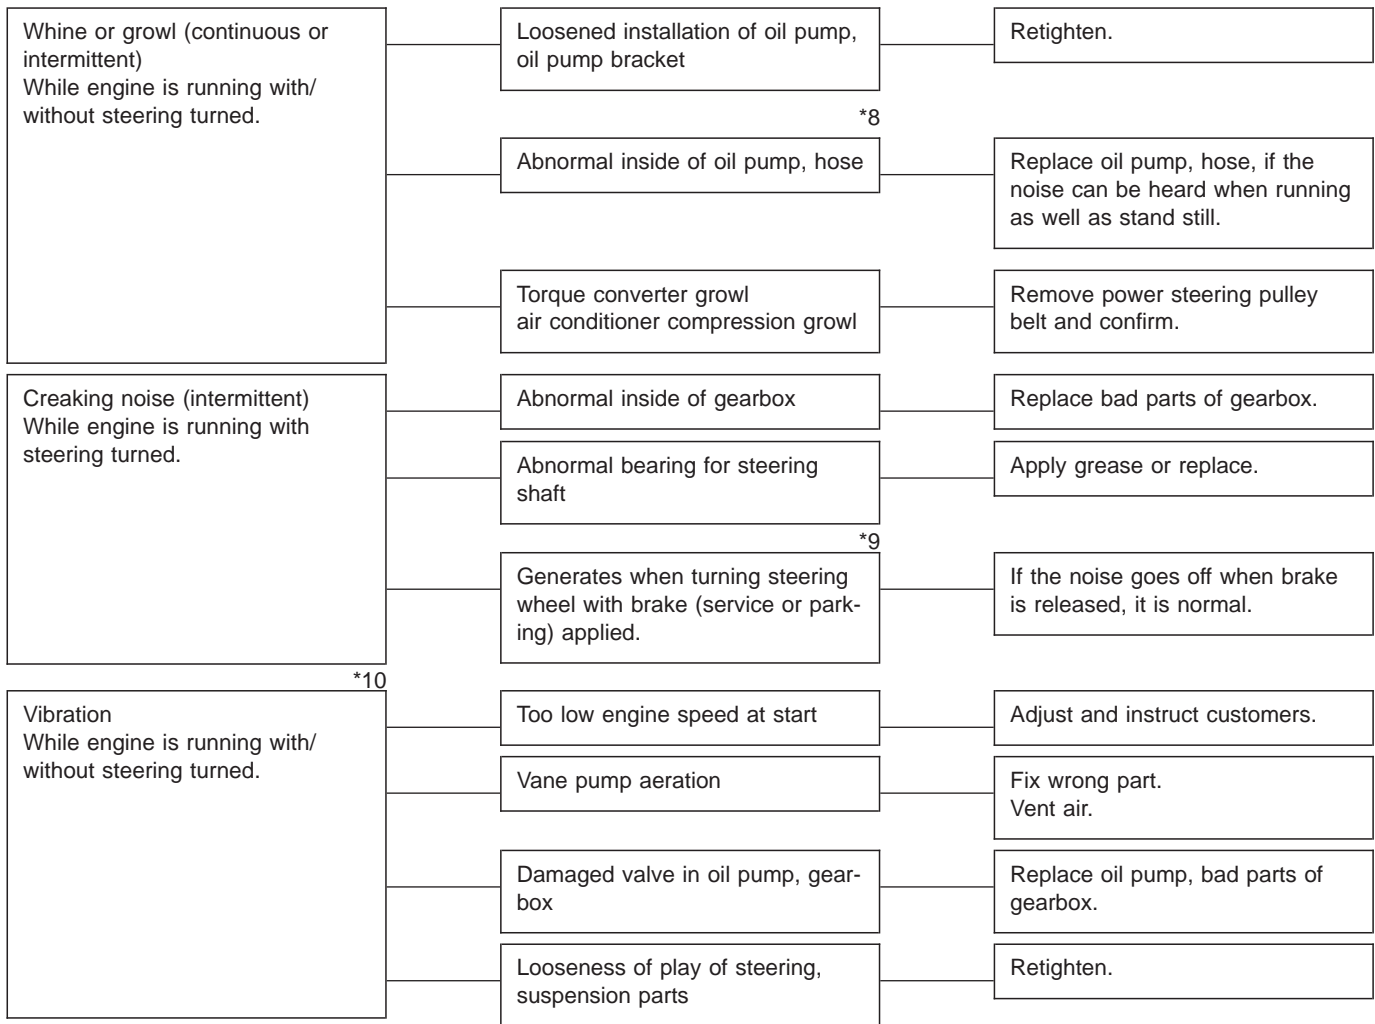
**\*8** Oil pump makes whine or growl noise slightly due to its mechanism. Even if the noise can be heard when steering wheel is turned at stand still there is no abnormal function in the system provided that the noise eliminates when the vehicle is running.

**\*9** When stopping with service brake and/or parking brake applied, power steering can be operated easily due to its light steering effort. If doing so, the disk rotates slightly and makes creaking noise. The noise is generated by creaking between the disk and pads. If the noise goes off when the brake is released, there is no abnormal function in the system.

**\*10** There may be a little vibration around the steering devices when turning steering wheel at standstill, even though the component parts are properly adjusted and have no defects.

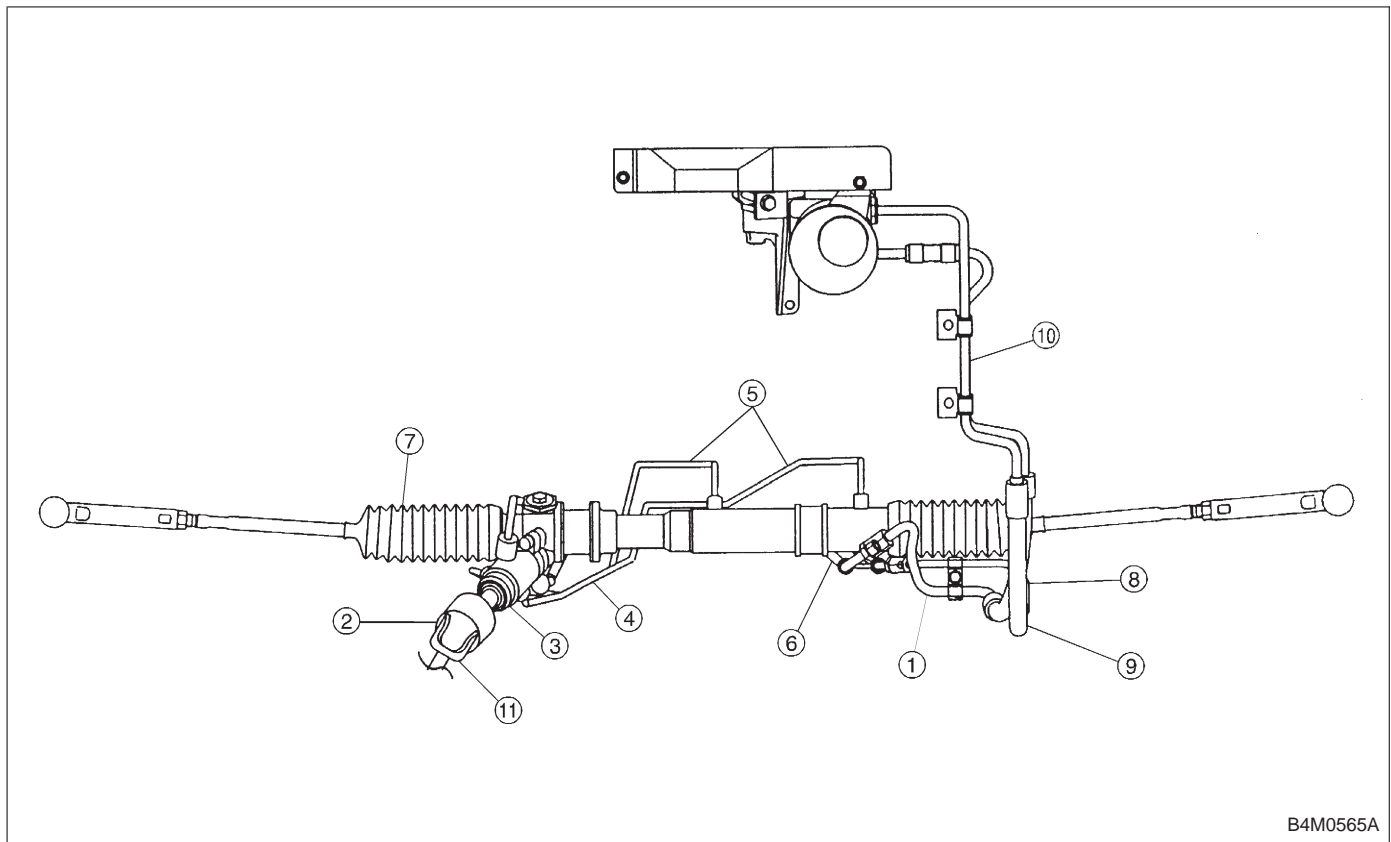
B4M0565A

This table lists various clearances that must be correctly adjusted to ensure normal vehicle driving without interfering noise, or any other faults.

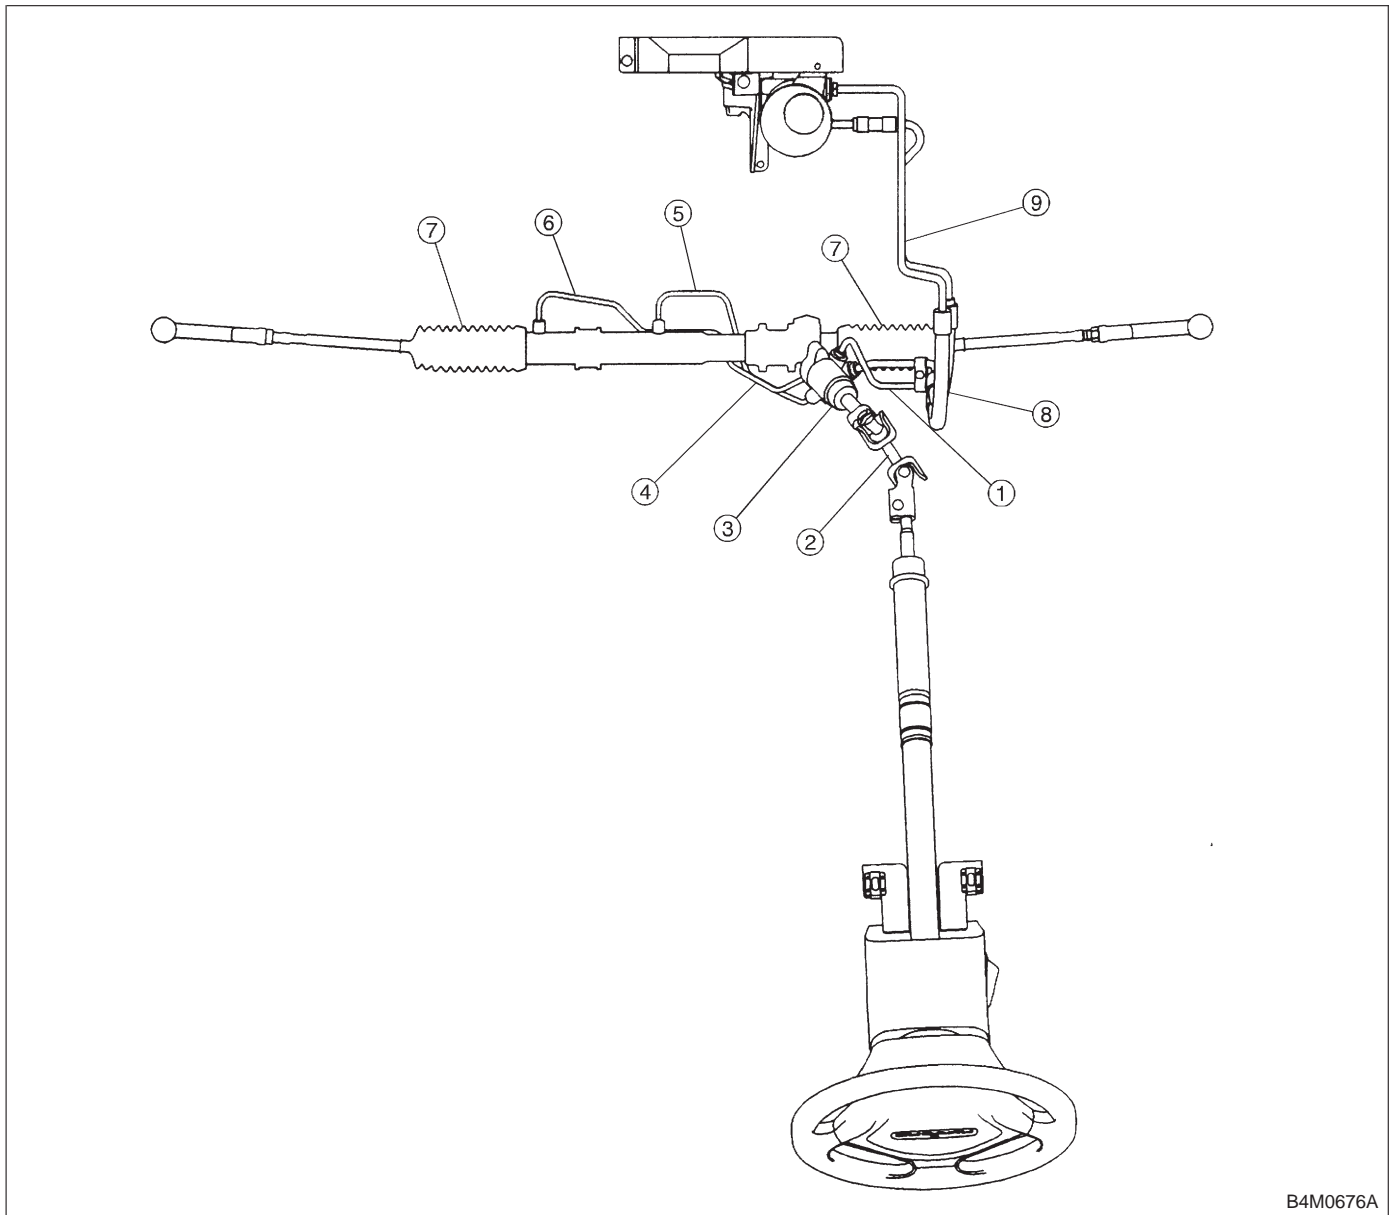
B4M0676A

This table lists various clearances that must be correctly adjusted to ensure normal vehicle driving without interfering noise, or any other faults.
