SERVICE BULLETIN

APPLICABILITY: 1999MY~2003MY Legacy, Forester, Impreza and Baja Vehicles

NUMBER: 12-78-03
DATE: 03/21/2003

SUBJECT: Floor Mat Hook Repair

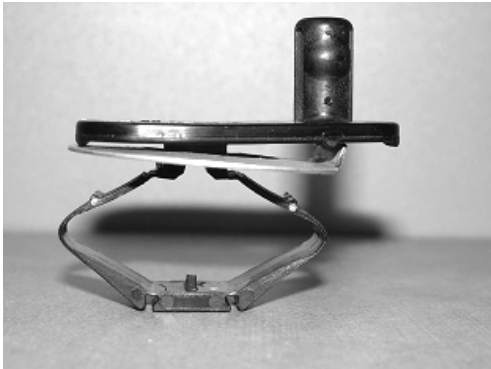
FIGURE 1

- 5) Install the washer/lock tab (part # 512300171) on the underside of the carpet with the “tang” pointing upward and aligned with the base of the floor mat hook as shown in figure 1 below. (Note: The carpet has been omitted from the photo in order to show detail.)
- 6) Using a pair of pliers with its jaws protected, compress the collapsible portion of the floor mat hook ensuring that the lock is engaged. (See figure 2 below.)
