2. Datum Points

- Datum points are specified for body repair.
- Guide holes, locators, and indents are provided to facilitate panel replacement and to increase alignment accuracy.
- Both right and left reference points are symmetrical.

DATUM POINTS

BODY STRUCTURE

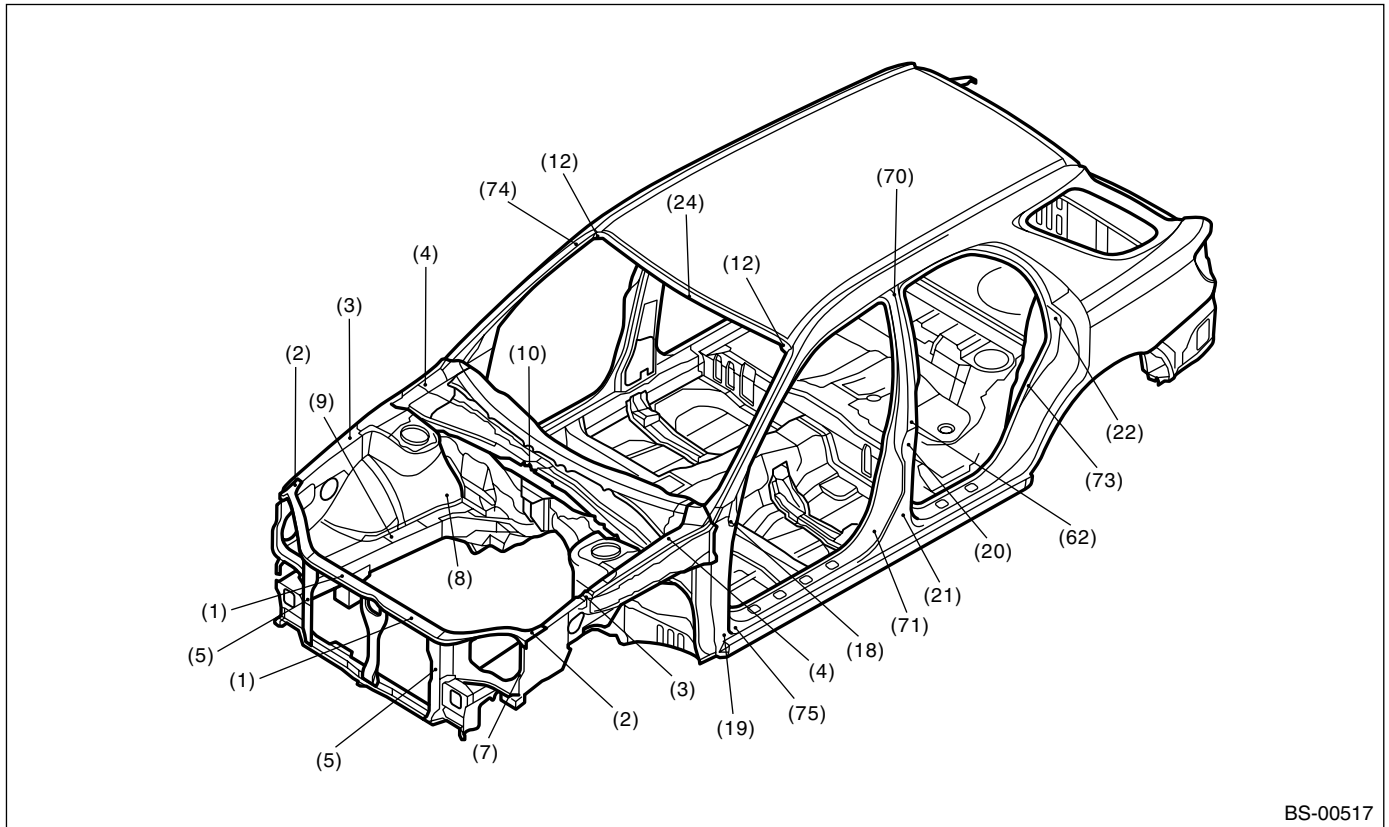
BS-00517

1. WAGON MODEL/SEDAN MODEL

| (1) Radiator attaching hole 12 mm (0.47 in) dia. (Symmetrical) | (10) Cowl panel attaching hole 6 mm (0.24 in) dia. (Vehicle center) | (24) Roof panel repair locator hollow |
| (2) Fender attaching hole 7 mm (0.28 in) dia. (Symmetrical) | (12) Front glass attaching hole RH 6.5 mm (0.256 in) dia. LH 6.5 × 10 mm (0.256 × 0.39 in) dia. | (62) Belt anchor attaching hole 11 mm (0.43 in) dia. (Symmetrical) |
| (3) Fender attaching hole 10 mm (0.39 in) dia. (Symmetrical) | (18) Fender attaching hole 12 mm (0.47 in) dia. (Symmetrical) | (70) Trim clip attaching hole 8.5 mm (0.335 in) dia. (Symmetrical) |
| (4) Hood hinge attaching hole 12 mm (0.47 in) dia. (Symmetrical) | (19) Fender attaching hole 12 mm (0.47 in) dia. (Symmetrical) | (71) Harness clip attaching hole 7 mm (0.28 in) dia. (Symmetrical) |
| (5) Radiator panel side gauge hole 20 mm (0.79 in) dia. (Symmetrical) | (20) Outer panel center pillar gauge hole 12 mm (0.47 in) dia. (Symmetrical) | (73) Harness clip attaching hole 7 mm (0.28 in) dia. (Symmetrical) |
| (7) Fender attaching hole 9 mm (0.35 in) dia. (Symmetrical) | (21) Outer panel center pillar gauge hole 12 mm (0.47 in) dia. (Symmetrical) | (74) Trim clip attaching hole 10 mm (0.39 in) dia. (Symmetrical) |
| (8) Gauge hole 12 mm (0.47 in) dia. (Symmetrical) | (22) Weather strip patch attaching hole 5.2 mm (0.205 in) dia. (Symmetrical) | (75) Insulator attaching hole 8 mm (0.31 in) dia. (Symmetrical) |
| (9) Front suspension crossmember attaching hole 12.4 mm (0.488 in) dia. (Symmetrical) | | |

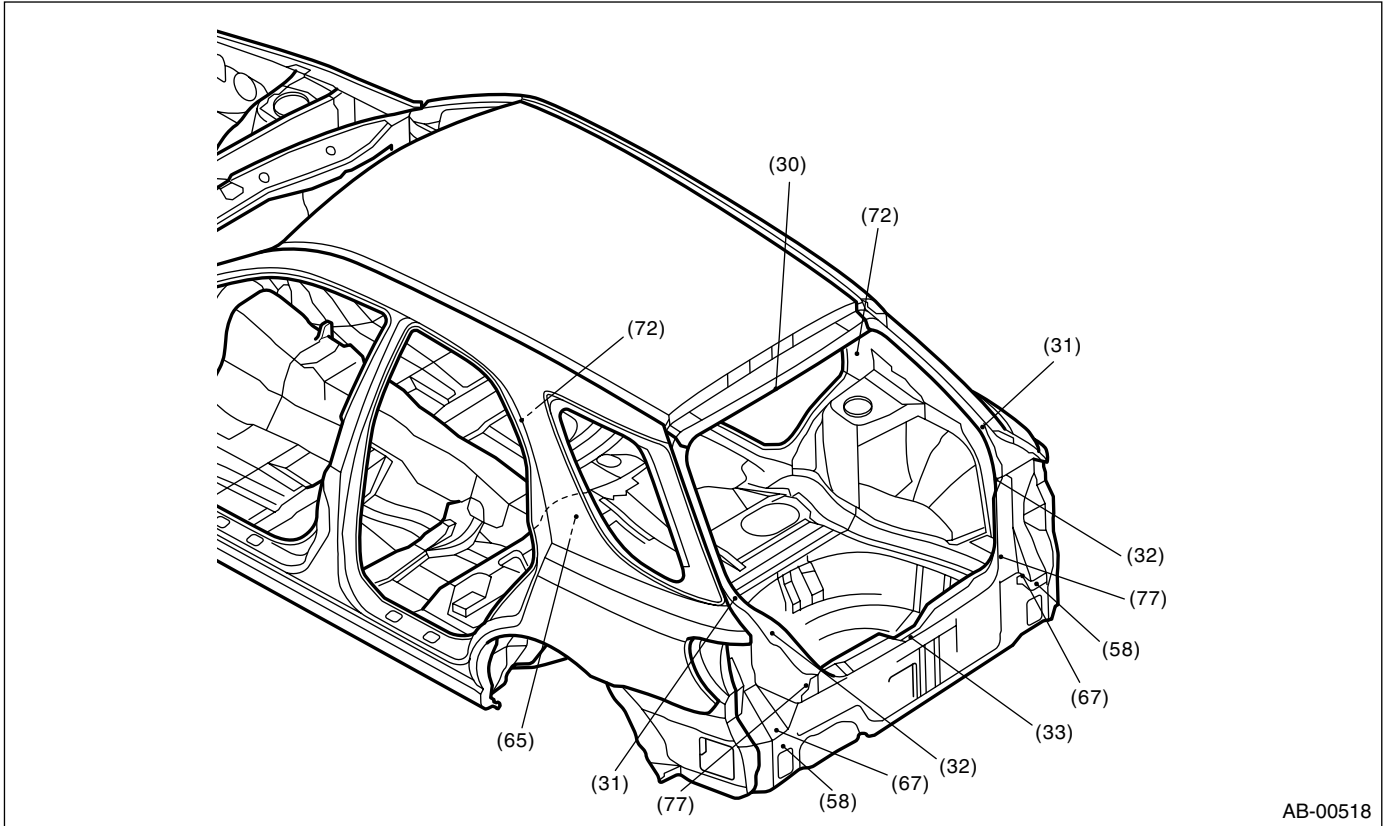
AB-00518

2. WAGON MODEL (REAR)

| (30) Child anchor attaching hole 11 mm (0.43 in) dia. | (33) Two striker attaching hole 15 mm (0.59 in) dia. | (67) Gusset floor rear side gauge hole 11.5 mm (0.453 in) dia. (Symmetrical) |
| (31) Washer hose attaching hole LH 7 mm (0.28 in) dia. | (58) Rear bumper plate nut attaching hole 11 mm (0.43 in) dia. (Symmetrical) | (72) Trim upper clip attaching hole 8.5 mm (0.335 in) dia. (Symmetrical) |
| (32) Rear combination light mounting hole 7 mm (0.28 in) dia. (Symmetrical) | (65) Floor mat clip attaching hole 8 mm (0.31 in) dia. | (77) Harness clip attaching hole 7 mm (0.28 in) dia. (Symmetrical) |

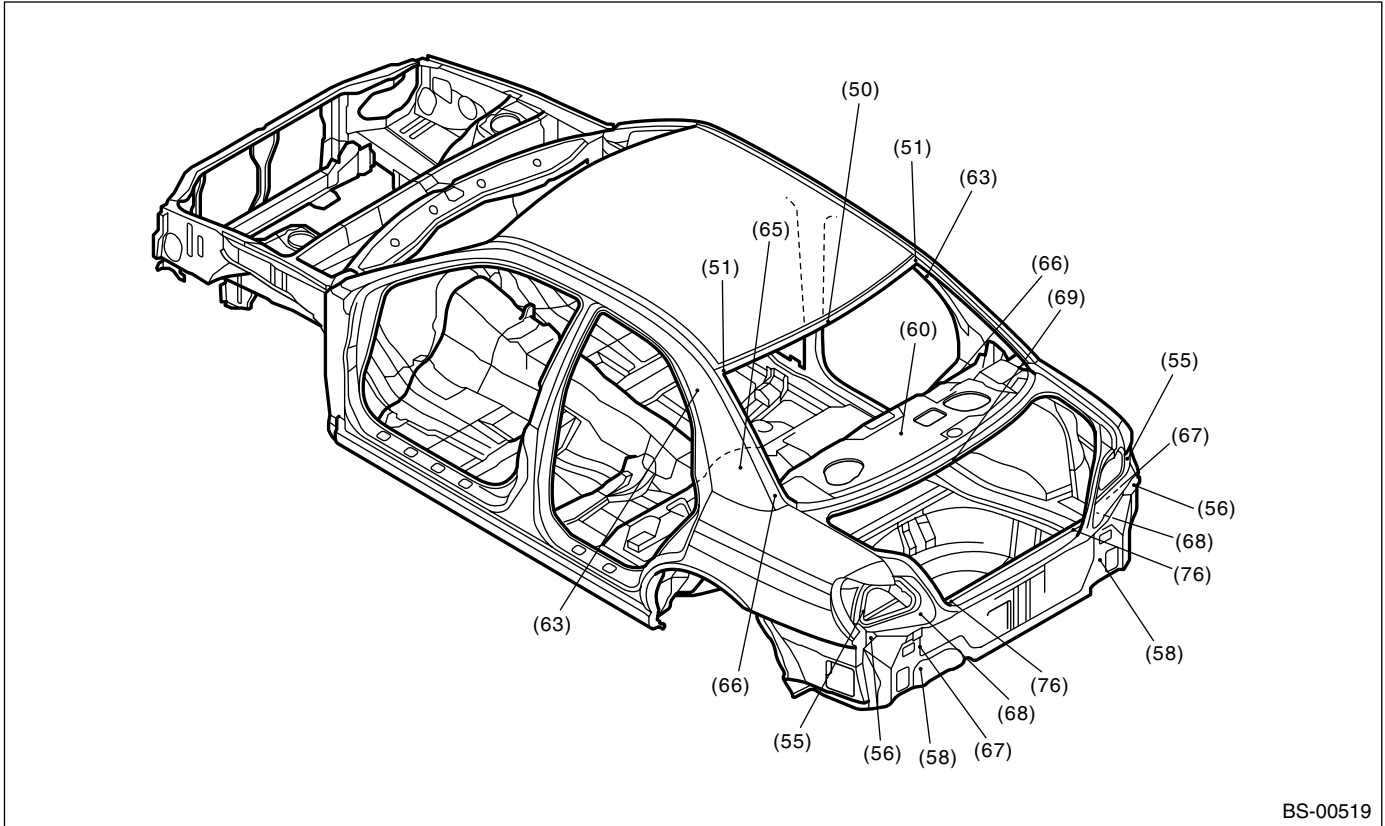
BS-00519

3. SEDAN MODEL (REAR)

(50) Repair locator hollow (Vehicle center)	(58) Rear bumper attaching hole 11 mm (0.43 in) dia. (Symmetrical)	(67) Gusset floor rear side gauge hole 11.5 mm (0.453 in) dia. (Symmetrical)
(51) Glass attaching hole RH 6.5 mm (0.256 in) dia. LH 6.5 × 10 mm (0.256 × 0.39 in) dia.	(60) Choke coil harness attaching hole 5.4 mm (0.213 in) dia.	(68) Rear skirt inner side gauge hole 10 mm (0.39 in) dia. (Symmetrical)
(55) Rear combination light mounting hole 8 mm (0.31 in) dia. (Symmetrical)	(63) Feeder line fixing hole 7 mm (0.28 in) dia. (Symmetrical)	(69) Rear panel (reinforcement) repair locator hollow (Vehicle center)
(56) Bumper attaching hole 7 mm (0.28 in) dia. (Symmetrical)	(65) Floor mat clip attaching hole 8 mm (0.31 in) dia.	(76) Press location hole 15 mm (0.59 in) dia. (Symmetrical)
	(66) Bulkhead rear gauge hole 10 mm (0.39 in) dia. (Symmetrical)

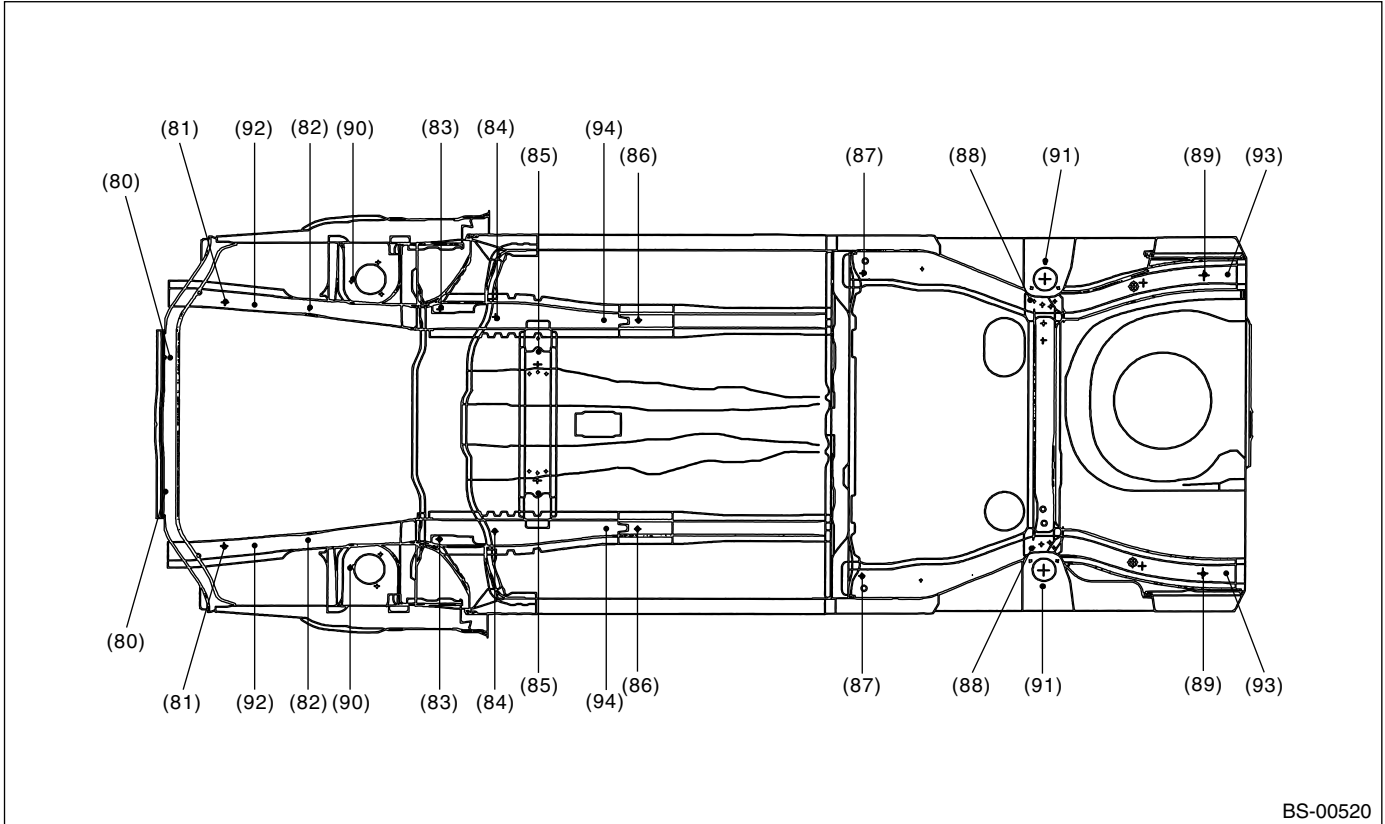
4. UNDERBODY

| (80) Radiator lower frame gauge hole 12 mm (0.47 in) dia. (Symmetrical) | (85) Transmission mount attaching hole 14 mm (0.55 in) dia. | (90) Strut mount attaching hole 9.5 mm (0.374 in) dia. (Symmetrical) |
| (81) Side frame gauge hole 20 mm (0.79 in) dia. (Symmetrical) | (86) Side frame gauge hole 18 mm (0.71 in) dia. (Symmetrical) | (91) Strut mount attaching hole 10 mm (0.39 in) dia. (Symmetrical) |
| (82) Front crossmember attaching hole 12.4 mm (0.488 in) dia. (Symmetrical) | (87) Rear differential attaching hole 16 mm (0.63 in) dia. (Symmetrical) | (92) Sub frame attaching hole 16 mm (0.63 in) dia. (Symmetrical) |
| (83) Suspension attaching hole 17 mm (0.67 in) dia. (Symmetrical) | (88) Rear suspension attaching hole 16 mm (0.63 in) dia. (Symmetrical) | (93) Bumper beam attaching hole RH 15 mm (0.59 in) dia. LH 19 × 15 mm (0.75 × 0.59 in) dia. |
| (84) Side frame gauge hole 20 mm (0.79 in) dia. (Symmetrical) | (89) Rear side frame gauge hole 15 mm (0.59 in) dia. (Symmetrical) | (94) Side frame gauge hole 15 mm (0.59 in) dia. (Symmetrical) |
