## 10. Side Airbag Sensor S802298

### A: REMOVAL S802298A18

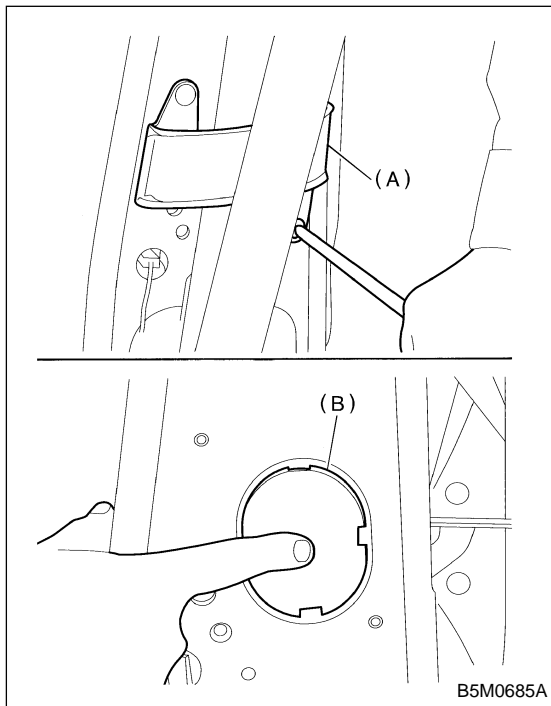
- 1) Turn ignition switch OFF.
- 2) Disconnect the ground cable from the battery, and wait for at least 20 seconds before starting work.
- 3) Remove center pillar lower trim. <Ref. to EI-43 REMOVAL, Lower Inner Trim.>
- 4) Remove Outer Belt (FRONT). <Ref. to 8 REMOVAL, Front Seat Belt.>
- 5) Remove bracket (A), and then remove cap (B).

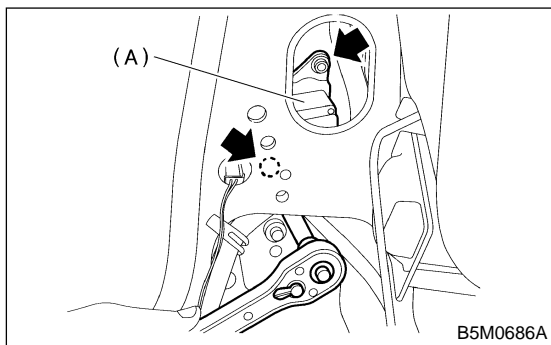
- 6) Using E12 TORX® remove two TORX® nuts, and then detach side airbag sensor (A).

Use new TORX® nuts during re-assembly.  
Install in the reverse order of removal.
