19. Rear Turn Signal Light Bulb

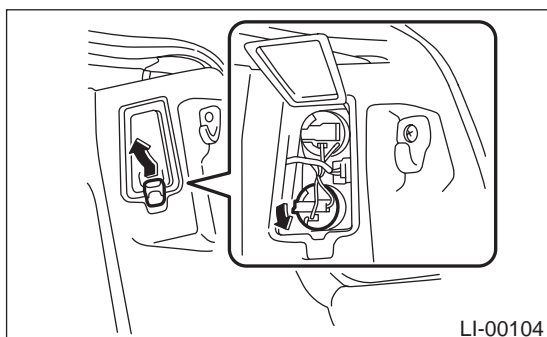
- 1) Open trunk lid and remove cover.

- 2) Turn the socket and remove the bulb.

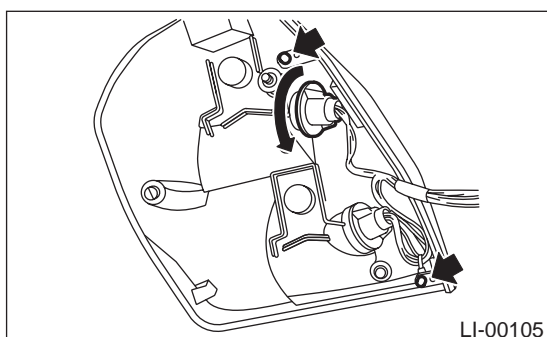
- 1) Remove rear combination light assembly. <Ref. to LI-19, WAGON, REMOVAL, Rear Combination Light Assembly.>
- 2) Remove the light cover mounting screws then detach the cover.
- 3) Turn the socket and remove the bulb.
